# Manhole Inspection Summary

Manhole # S37Q\_\_007MH

Insp Date: **1/16/08 10:49 AM**

**Location** Address: **445 grindall st**

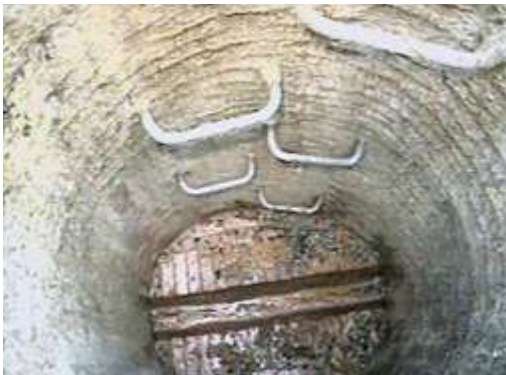
Defect 1

Infiltration: ☐ None ☒ **Joint** ☐ Cracks ☐ Mortar ☐ Roots ☐ Wall

Infiltration Evidence in Chimney

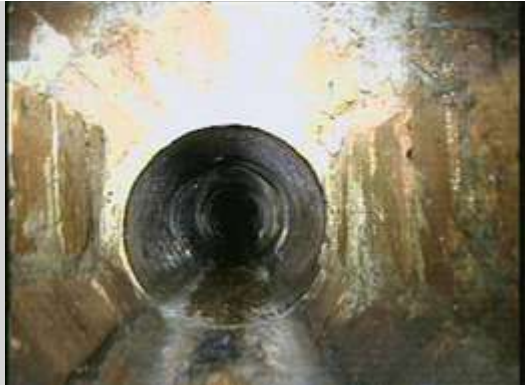
12 O'Clock Outflow

8 in. Circular Gravity Sewer  
Pipe Out @ 12 O'Clock

Pipe Material: **Clay** ☐ Pipe Lined

Invert Depth: **9.40** (ft.) Flow Characteristics: **Fast**

Infiltration: **None** Pipe Seal Cond: **Unknown**

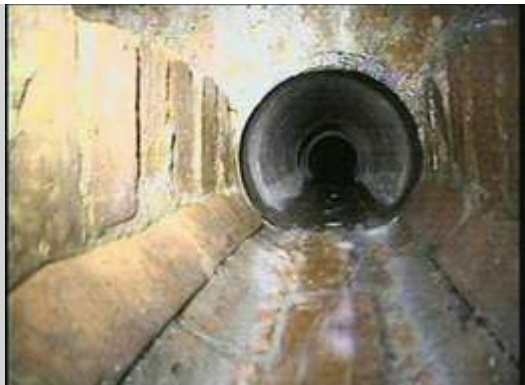
6 O'Clock Inflow

8 in. Circular Gravity Sewer  
Pipe In @ 6 O'Clock

Pipe Material: **Clay** ☐ Pipe Lined

Invert Depth: **9.20** (ft.) Flow Characteristics: **Fast**

Infiltration: **None** Pipe Seal Cond: **Unknown**
